# Manhole Inspection Summary

Manhole # S130\_\_022MH

Insp Date: **3/24/08 8:00 AM**

**Location** Address: **501 Safford ST**

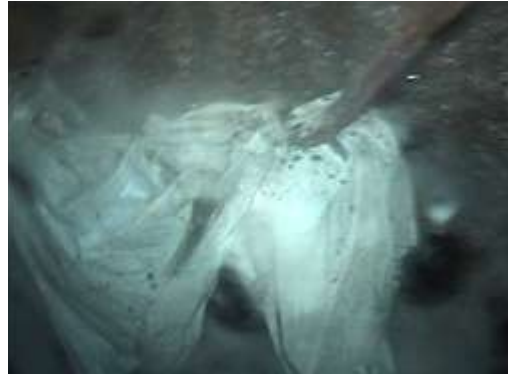
Defect 2

**Surcharge** ☒ **Evidence Of Surcharge** Depth: **3** (ft.) ☐ Active Surcharge Present

signs of surcharge

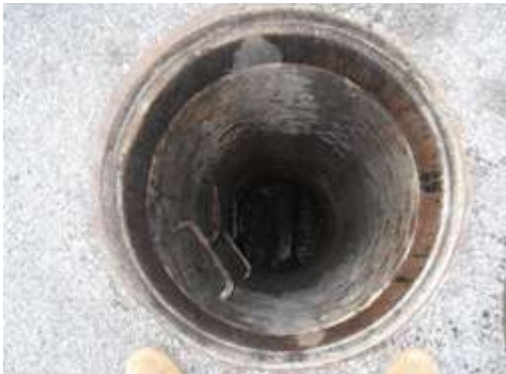
Defect 4

**Frame** Offset: **0** (in.) Condition: ☐ Sound ☐ Cracked ☒ **Leaks**

frame leaks

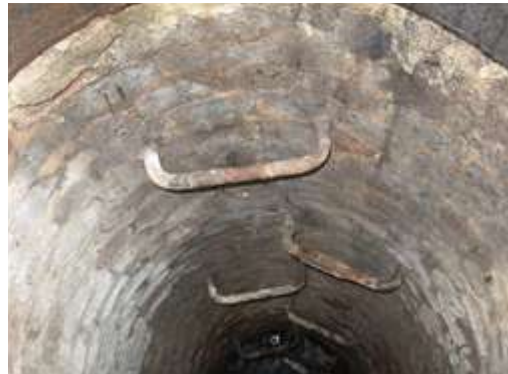
Defect 1

Condition: ☐ Sound ☐ Cracked ☐ Root Intrusion ☐ Loose Brick ☒ **Deteriorated**

Infiltration: ☐ None ☐ Joint ☐ Cracks ☒ **Mortar** ☐ Roots ☒ **Wall**

Infiltration: ☐ None ☐ Joint ☐ Cracks ☐ Mortar ☐ Roots ☒ **Wall**

**Steps** Count: **8** Missing: **0** ☒ **Corroded**

chimney deteriorated, signs of infiltration in chimney wall/mortar, and corbel wall, corroded steps

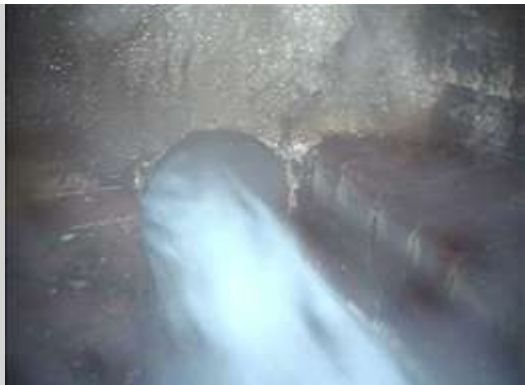
6 O'Clock Inflow

Pipe Height: **8.4** (in.) Rod and Bar (Angled)  
Pipe Material: **Clay** ☐ Pipe Lined  
Invert Depth: **16.42** (ft.) Flow Characteristics: **Fast**  
Deposits: ☒ None ☐ Mud ☐ Sludge ☐ Debris ☐ Grease  
Silt Depth: **0** (in.) Deposits Extent:  
Infiltration: **Evidence** Pipe Seal Cond: **Unknown**
